**Guildhall Chambers
Broad Street
Bristol**

Archaeological Evaluation and
Historic Building Recording

CA Project: 4728
CA Report: 14106
OASIS ID: Cotswold2-173344

May 2015

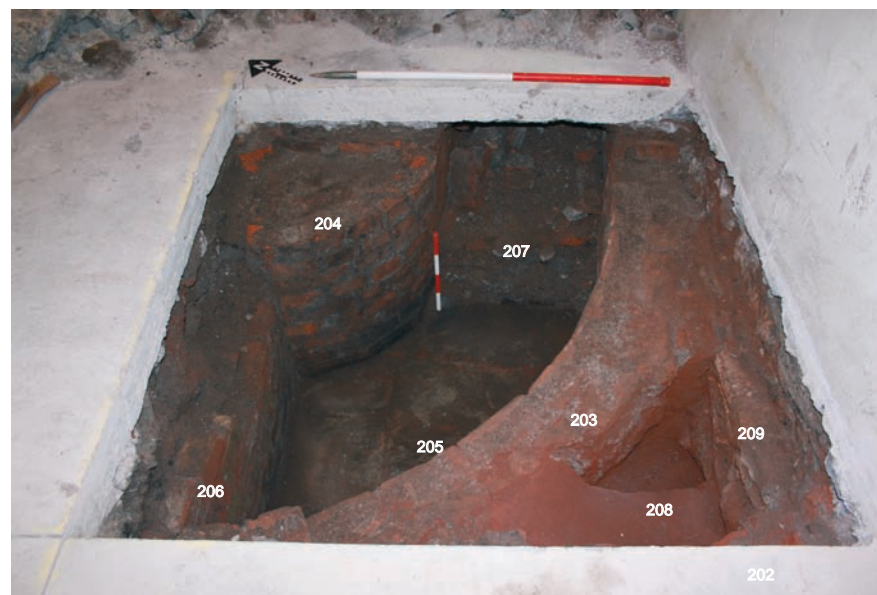
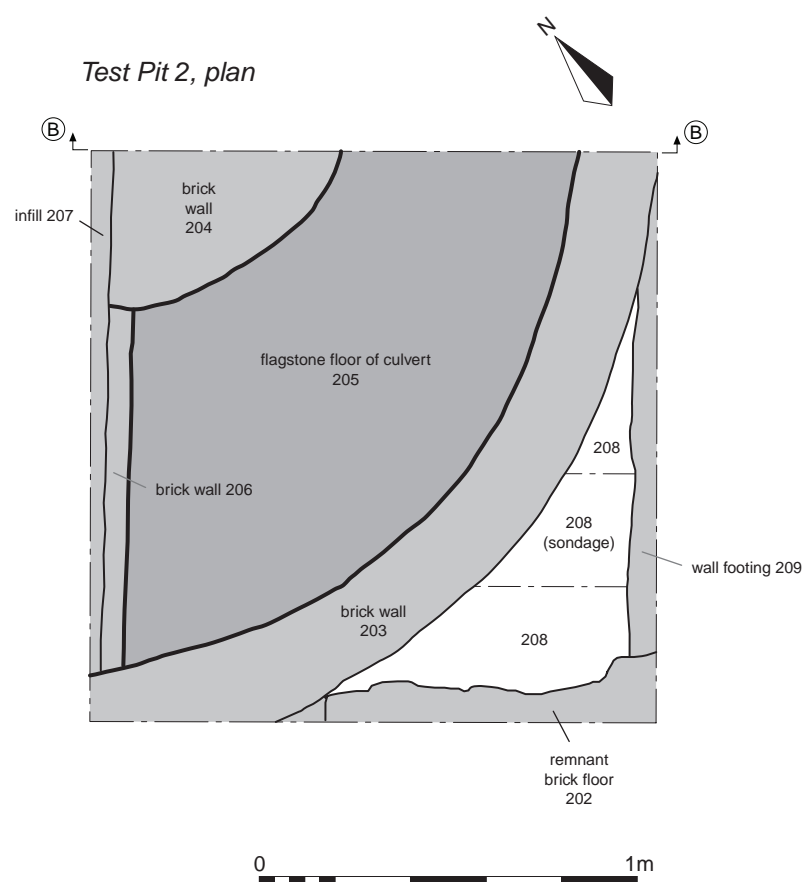
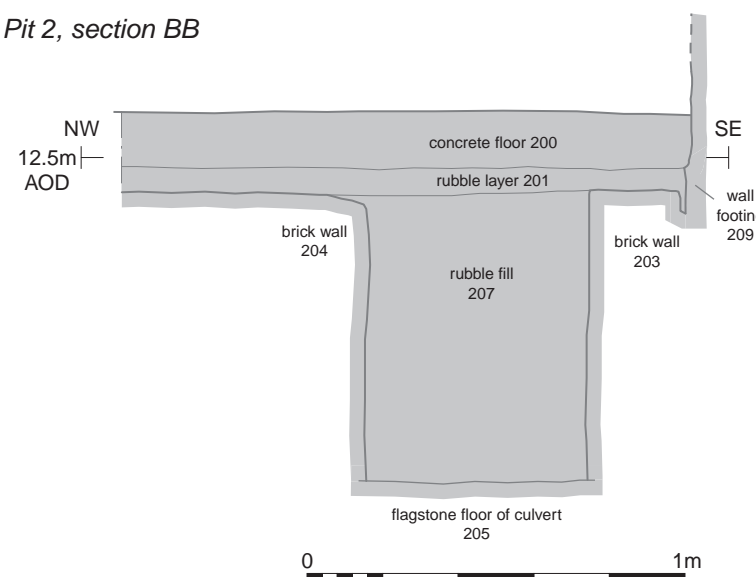
FIGURE TITLE
Test Pit 2: plan, section and photograph

- 2.3 The natural substrate 208 was also cut by a curving culvert structure constructed with a sandstone flagstone base 205 and brick-built walls 203 and 204. A brick surface 202, only partially surviving, overlay the uppermost brick course of culvert wall 203 and overlay wall footing 209. The drain, with an internal width of 0.58m and depth of 0.75m, contained a loose backfill deposit 207 which included iron bands and large sandstone flagstone fragments likely to have been used together to cap the culvert. An overlying rubble layer 201 supported the extant concrete basement floor 200.

Test Pit 2, looking north-east (scale 1m)

Test Pit 2, section BB

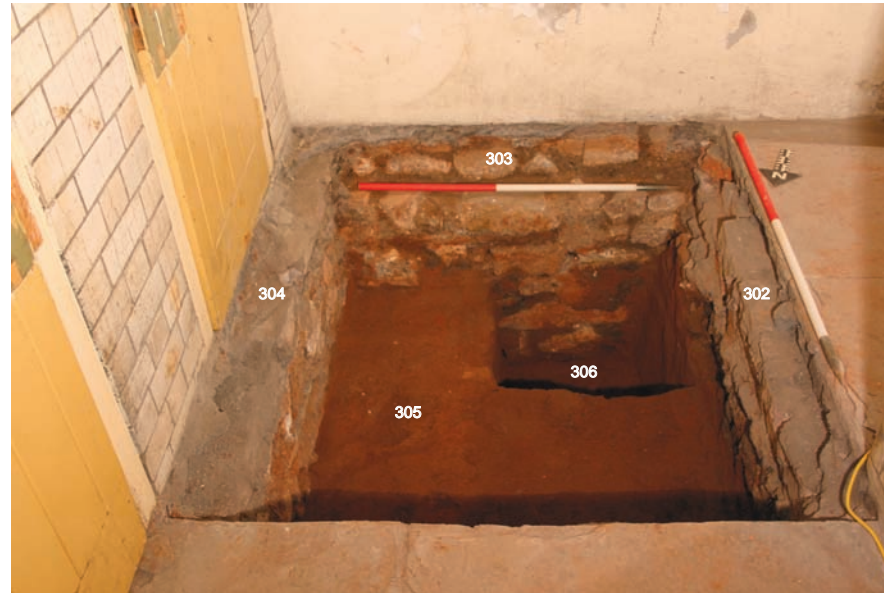
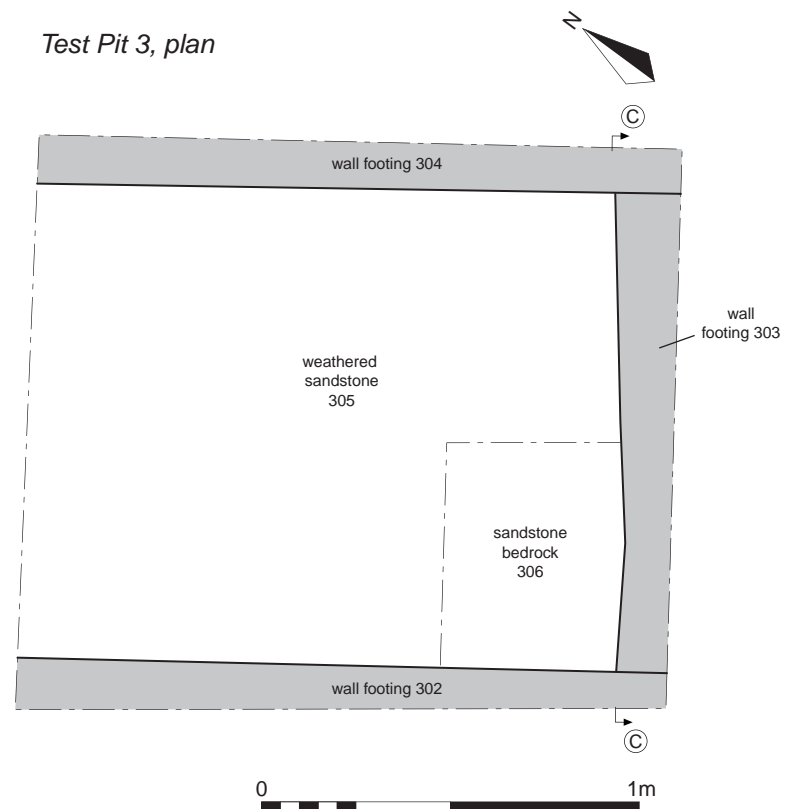
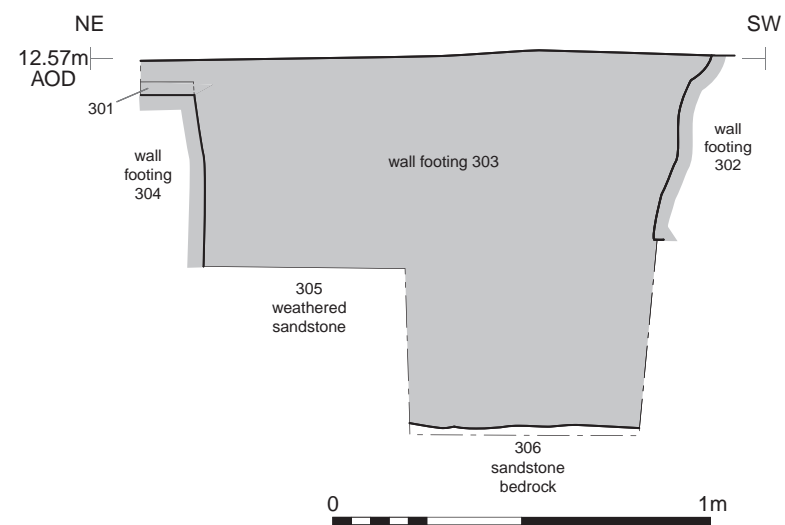
FIGURE TITLE
Test Pit 3: plan, section and photograph

Test Pit 3, looking south-east (scales 1m)

Test Pit 3, plan

Section CC

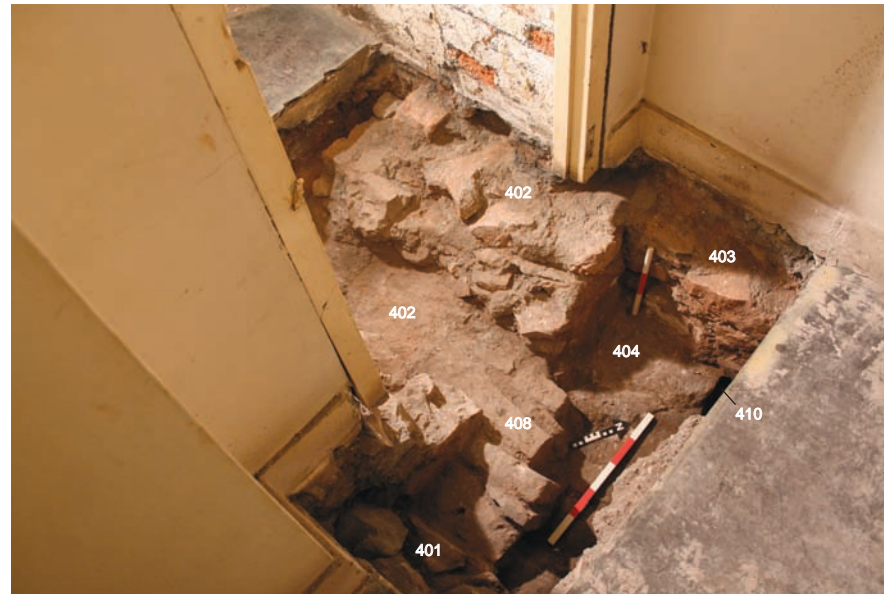
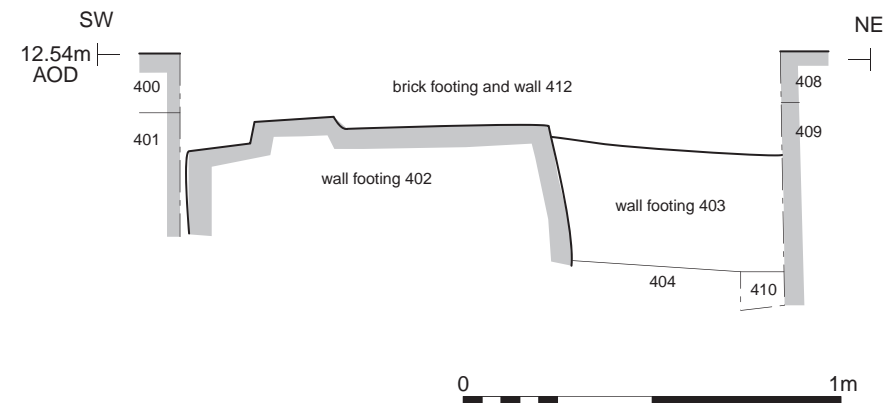
FIGURE TITLE
Test Pit 4: plan, section and photograph

- 2.5 Sandstone bedrock 404 and overlying weathered sandstone 410 was encountered at the limit of excavation at 0.6m bpgl (at 12m AOD). An overlying mortar and stone deposit 409, only partially exposed in the north-western corner of Test Pit 4, may represent infill of a footing trench adjacent to an undated, north-east/south-west-aligned, sandstone wall foundation 403. This stone footing, bonded with a soft pink mortar, appears to represent part of a wall not clearly associated with the ground plan of the extant basement. A pitched sandstone footing 408 overlay the natural bedrock 404 and supported an overlying north-east/south-west-aligned sandstone wall footing 402, 0.9m in width and surviving 0.25m in height, bonded with a hard grey ashy mortar. The alignment, width and position of wall footing 402 correlated with that of an extant basement wall, through which an opening had been created during construction of a basement bathroom. Wall footing 402 was cut through by a modern pipe trench 405, containing a glazed ceramic drain pipe 407 and backfill 406, the latter sealed by concrete basement floor 400.

Test Pit 4, looking north-west (scales 0.3m and 0.5m)

Section DD

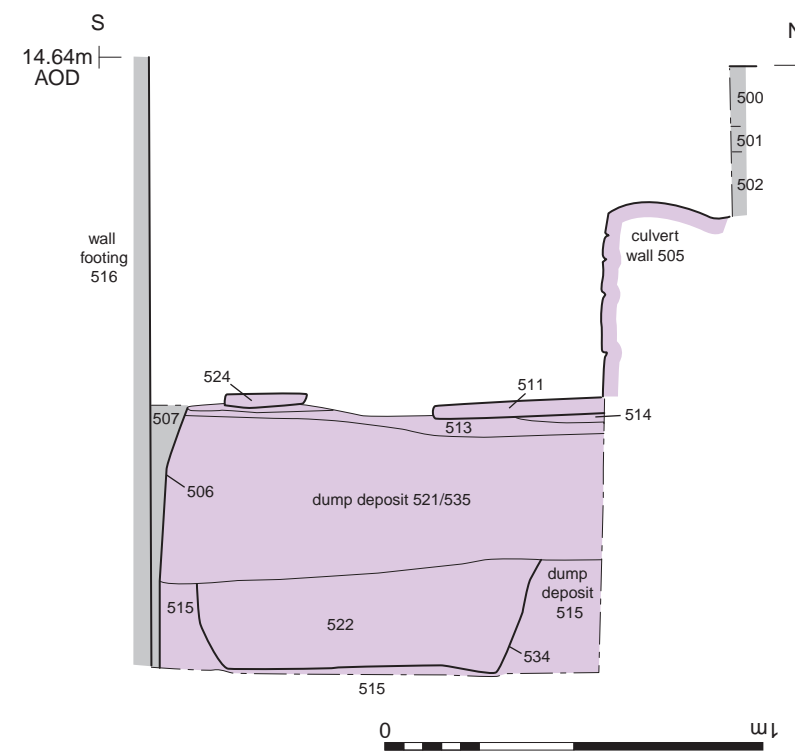
FIGURE TITLE
Test Pit 5: plan and section

containing one 12th to 13th-century AD pot sherd, and an overlying pink mortar bedding layer 514 supported culver base sandstone slabs 511 and 524 and overlying sandstone side walls 505 and 524, bonded with a soft pink mortar (at 14.28m AOD). One mid 12th to mid 13th-century AD pot sherd was noted adhering to the mortar used to bond culvert wall 505. Surviving sandstone capstones 526 were mortar-bonded to the top of the culvert side walls. Culvert fill 527 yielded one late 17th to 18th-century AD pantile fragment, a mortar fragment and four clay tobacco pipe stem fragments.

- 2.8 Culvert 505/524 was cut through by a north-east/south-west-aligned foundation trench 506 for wall footing 516, comprised of sandstone pieces bonded with a hard grey ashy mortar, for the extant south-eastern wall of Court 13. Residual artefacts recovered from footing trench 506 backfill 507 included a sherd of mid 17th to 18th-century AD pottery, a clay pipe stem, plaster and mortar fragments and three worked stone fragments. The latter comprised two pieces probably from an attachment to the former, 12th-century, arcade pier and a stone moulding possibly from a late medieval or post-medieval chimney piece. Two plaster fragments from 507, with a barred fleur de lys design painted in red and gold stripes, are of probable mid 16th-century AD date (Fig. 15). A further six moulded Plaster of Paris fragments from 507 are of 19th to early 20th-century date.

- 2.10 Two sub-square vertical-sided pits 517 and 519/528/530 were associated with construction of square concrete foundation pads 503 and 504. Due to health and safety considerations it was not possible to reach the base of these supports, although concrete pad 503 was in excess of 2m deep (a layer of concrete was noted extending across pit 517 at the limit of excavation, at 12.48m AOD). Concrete foundation pad 504 was at least 0.95m in depth, and concrete layers 532 and 533 extended across the base of its construction pit (at 13.69m AOD).

Test Pit 5, plan

Section EE

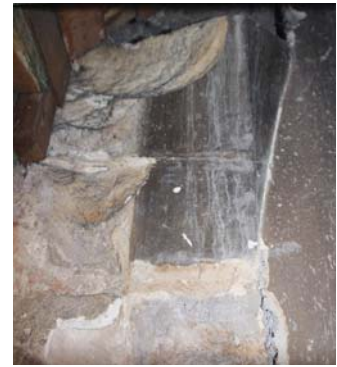
8

6, however, although a horizontal limestone slab noted in the extant south-eastern wall of Court 13, immediately beneath the remains of the stone capital and corbel, may represent a support stone for the 12th-century arcade structure which had been retained *in situ* during 19th-century construction works.

View of the arch-spring over the corbel above Test Pit 5

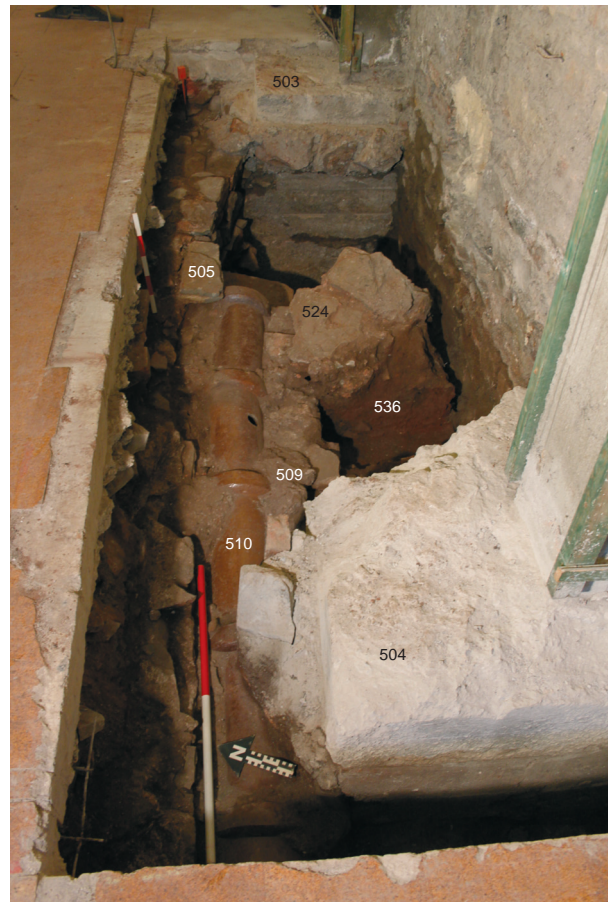
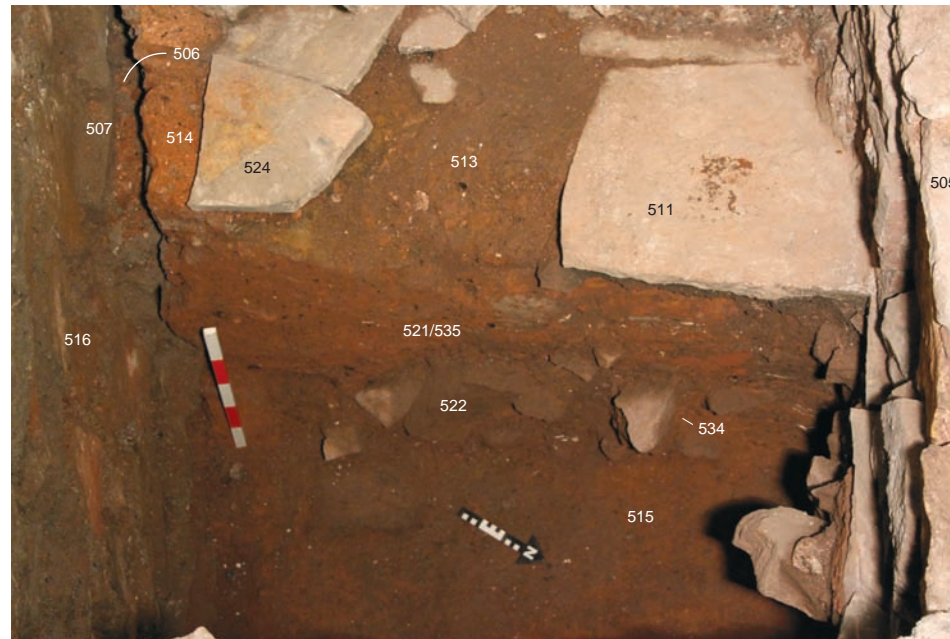
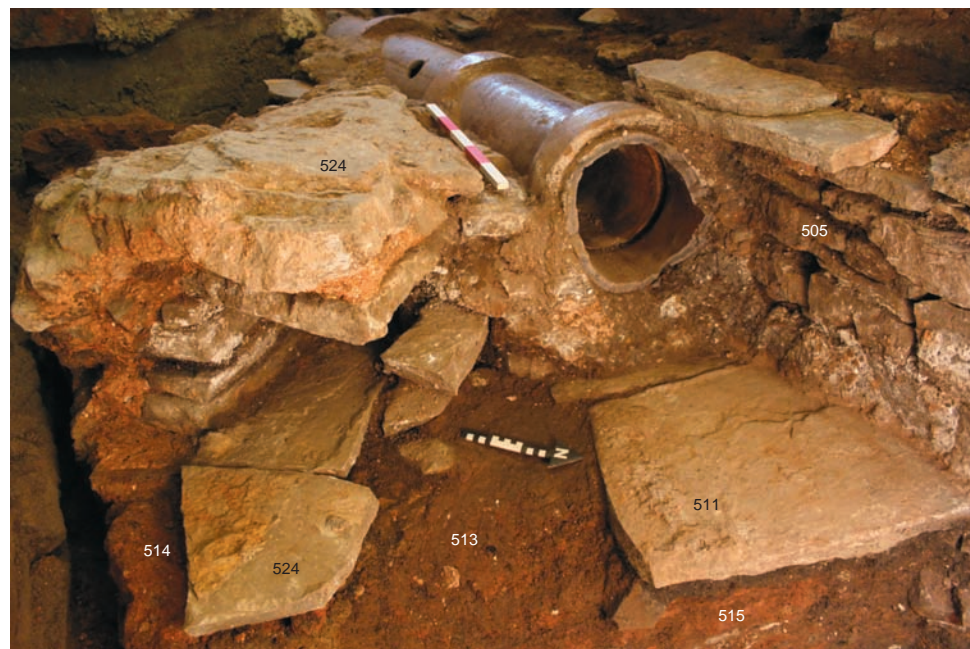
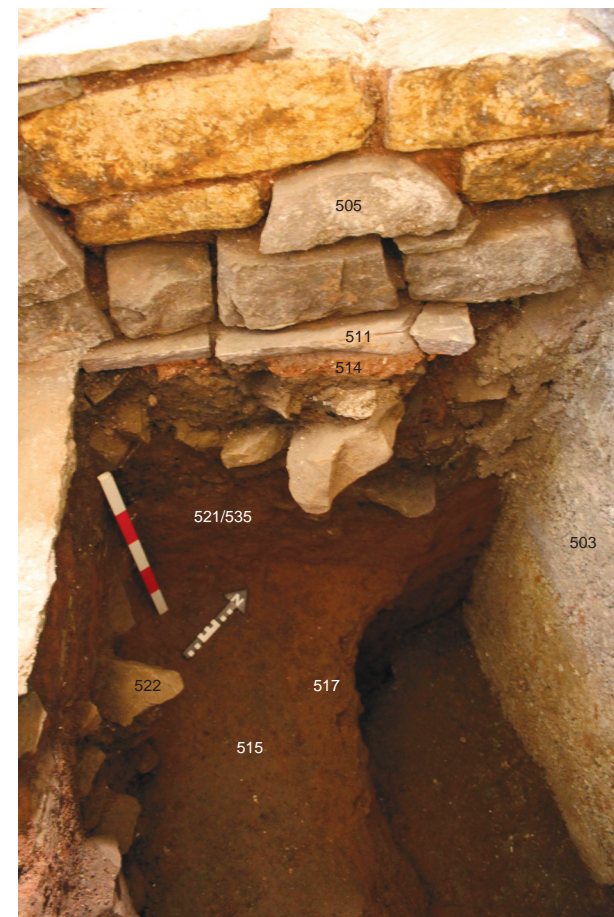
- 9a Test Pit 5, looking north-east (0.5m and 1m scales)
- 9b Test Pit 5, showing culvert walls 505 and 524, looking north-west (0.5m scale)
- 9c Test Pit 5, feature 534, looking north-west (0.5m scale)
- 9d Test Pit 5, showing culvert wall 505 and dump deposit 521/535, looking north-west

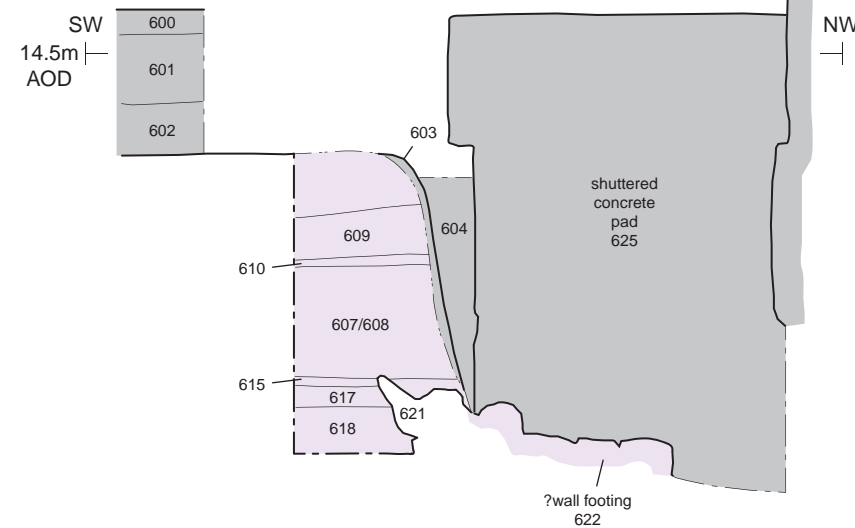
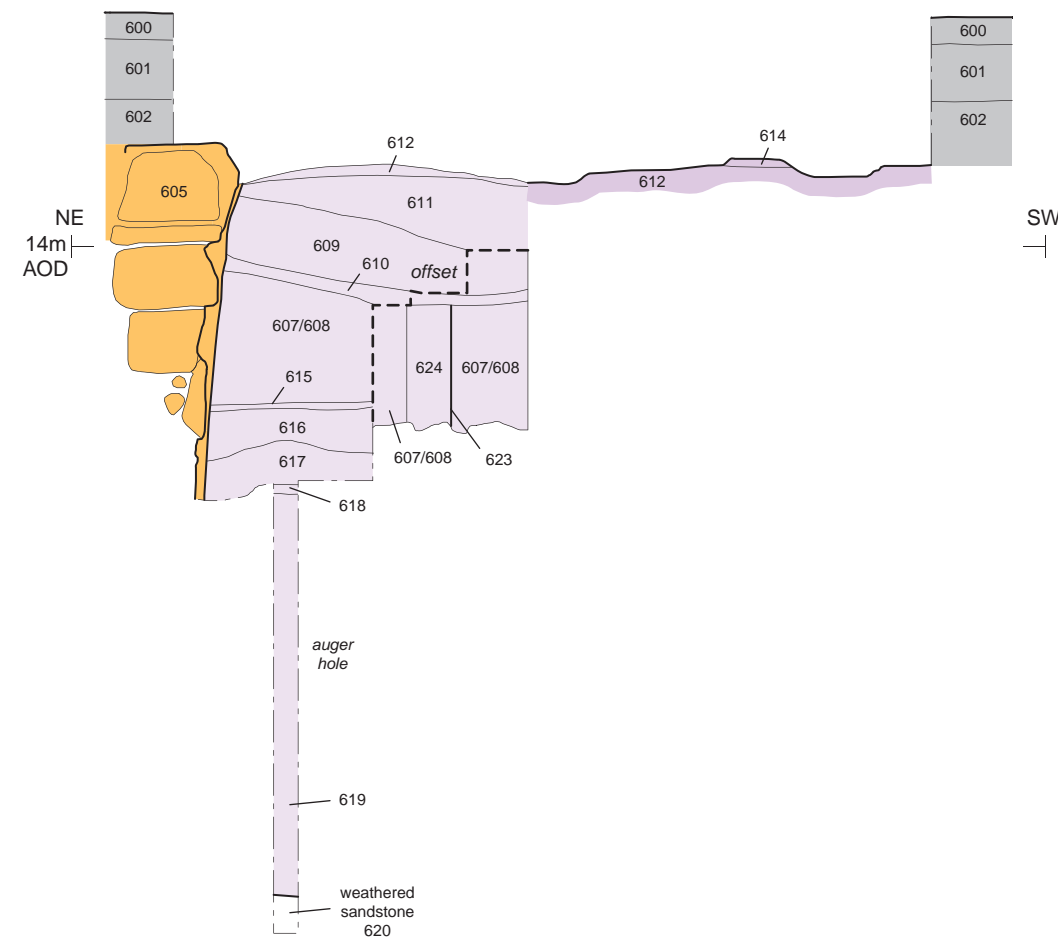
- 2.15 A steep-sided cut 603 for a concrete foundation pad 625, supporting a metal column 626, contained a backfill deposit 604. In addition to modern artefacts, residual finds from 604 included one sherd of medieval pottery, post-medieval CBM fragments, worked limestone pieces and moulded Plaster of Paris fragments of 19th-century date. An east/west-aligned footing trench, extending northeast-ward from pit 603, contained an associated concrete beam 627 which supported a section of extant brick wall 628. Modern make-up layer 602 supported reinforced concrete layer 601 beneath the extant concrete floor 600 of Court 13.

- 3.23 Test Pit 6, against the north-western wall of Court 13, provides further information on the medieval and later development of the 20 Small Street site. North/south-aligned wall footing trench 605, only partially exposed, was cut through an earlier dump deposit containing 12th to 13th-century AD pottery. Although undated artefactually, from its position and alignment it probably represents the foundation to the blocking wall of the arcade of the late 12th-century hall, potentially remodelled, depicted on an 1866 assize court plan.

Trench 6, Section GG

Trench 6, Section HH

Trench 6, plan

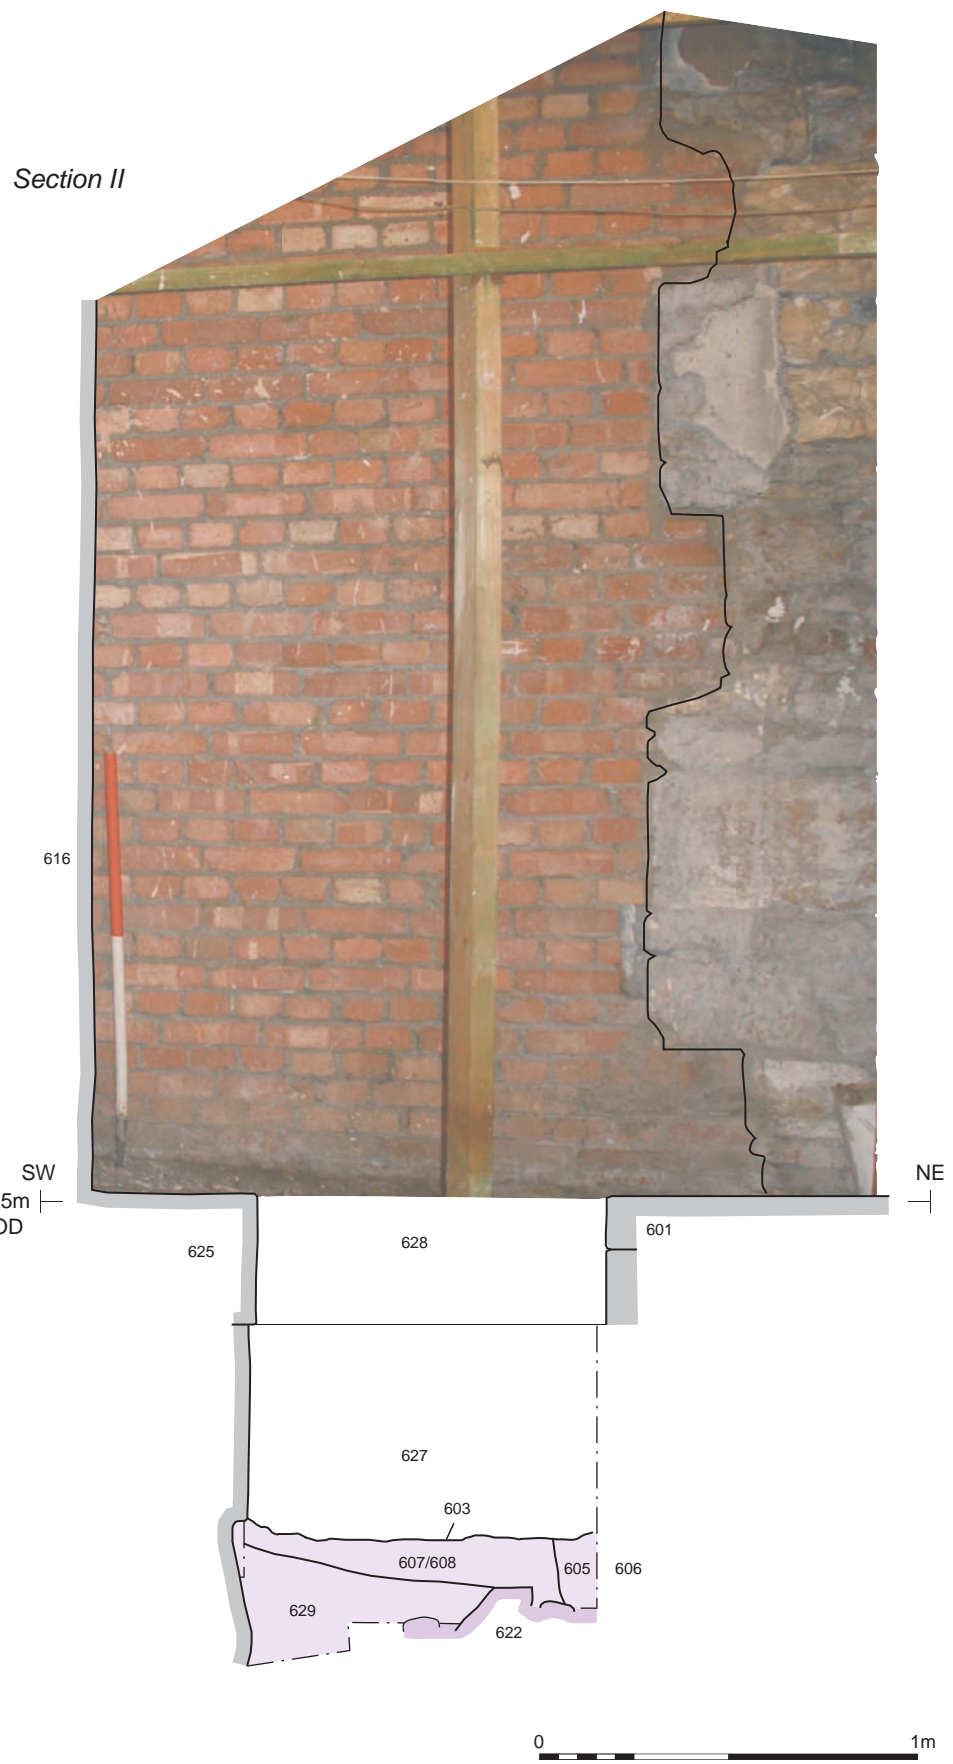
FIGURE TITLE
Test Pit 6: section/elevation

- medieval/post-medieval wall footings
- medieval/post-medieval deposits
- modern

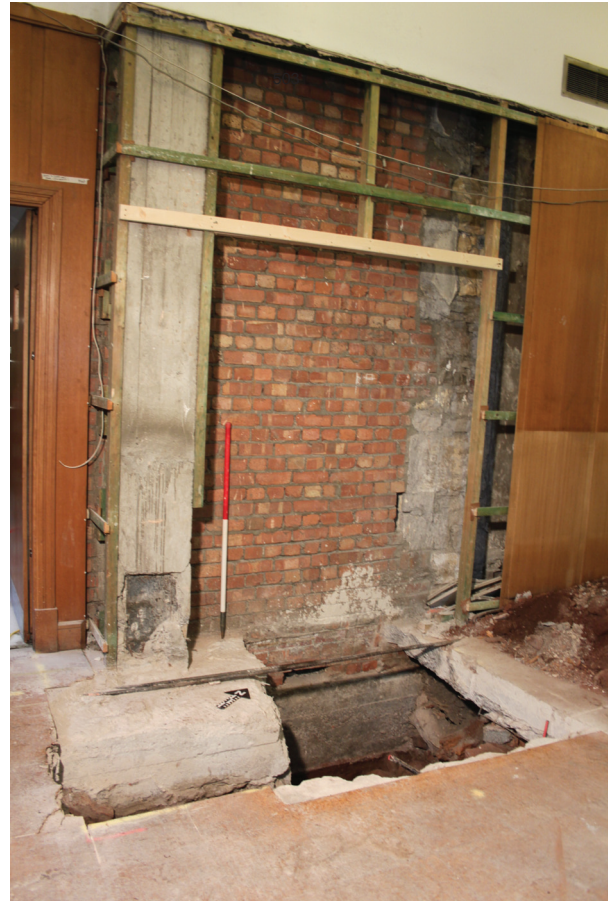
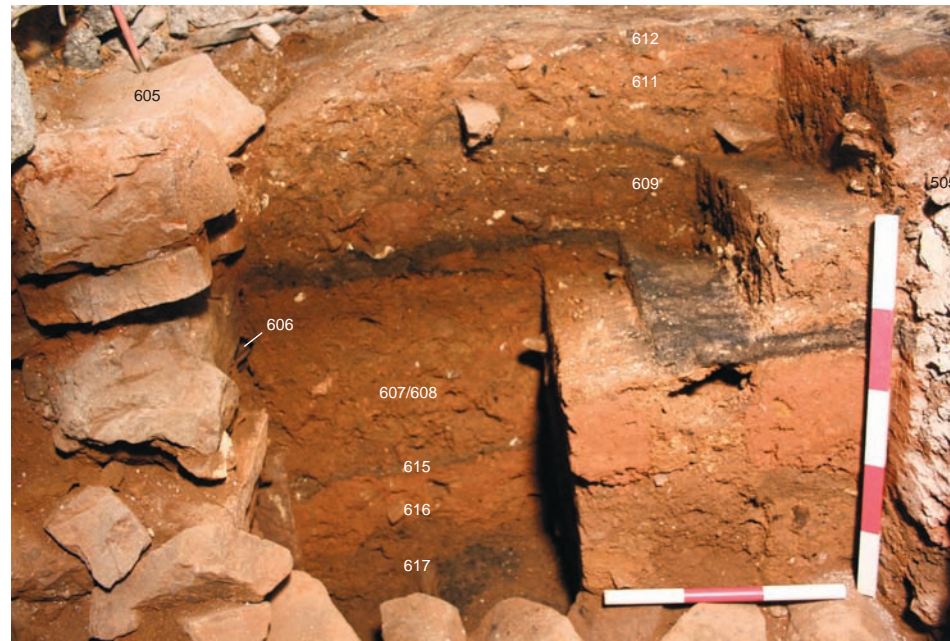
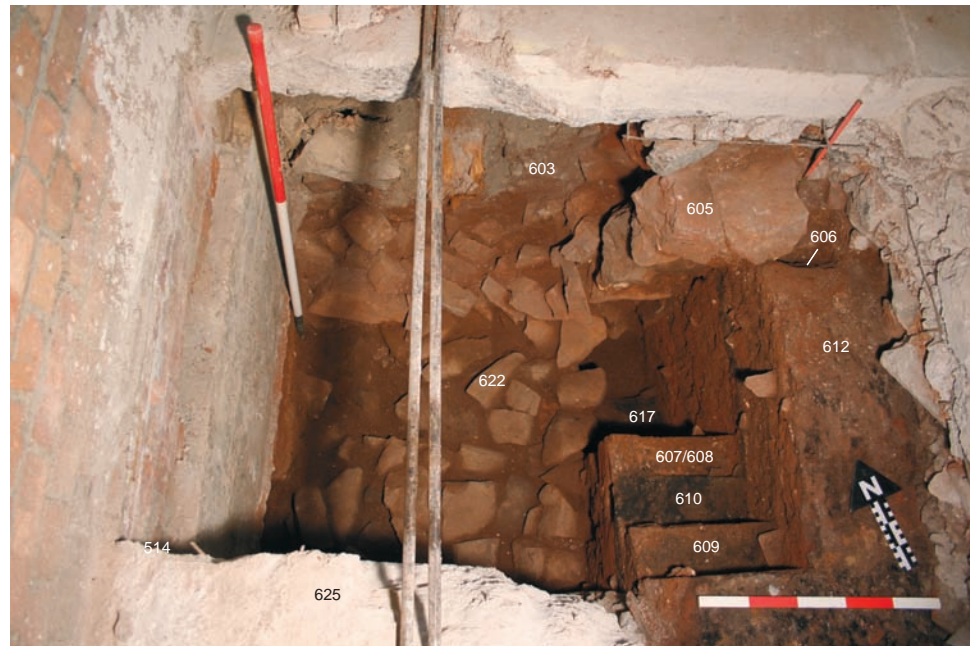
13a Test Pit 6 and extent north-west of court 13, looking north (1m scale)

13b Test Pit 6 looking north-east (0.5m and 1m scales)

13c Test Pit 6, looking south-east (0.3m and 0.5m scales)

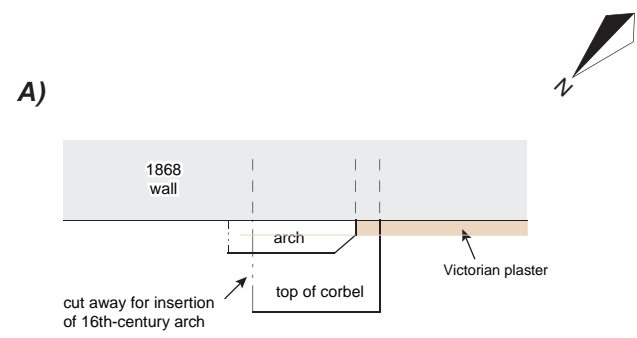
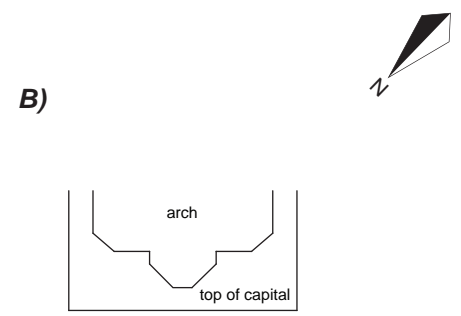
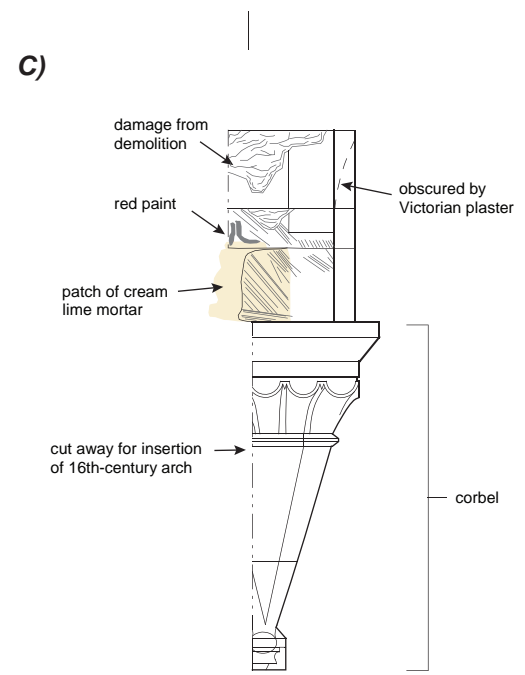
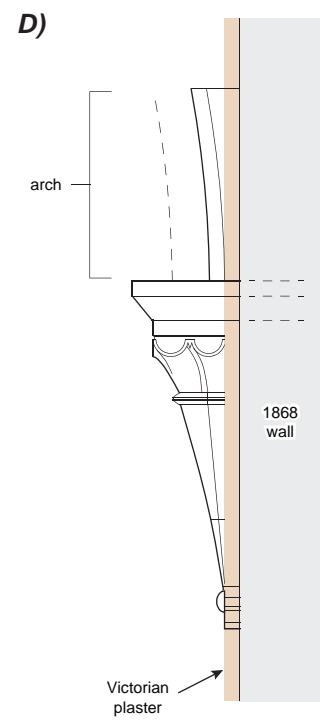
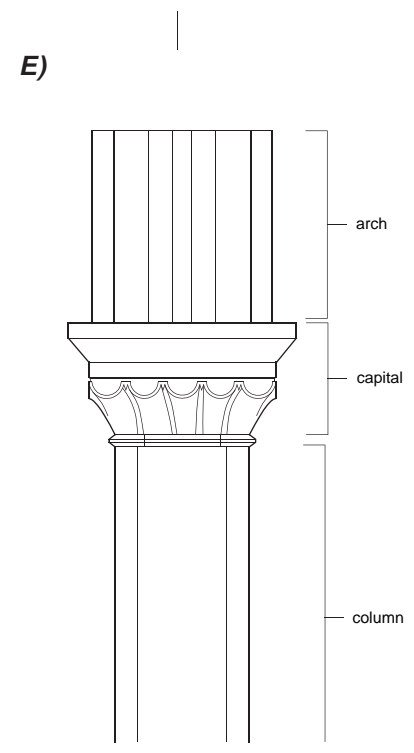
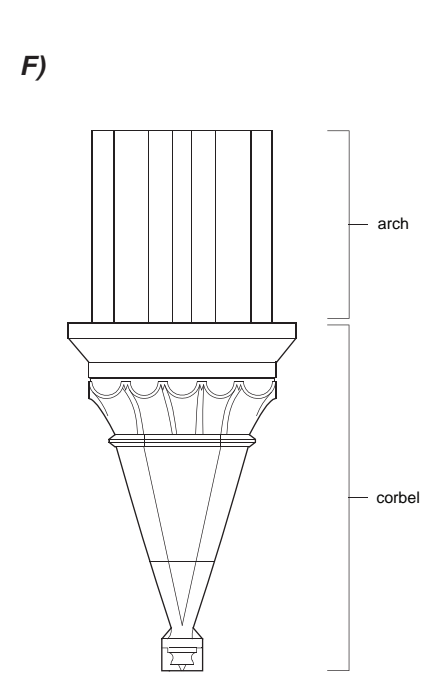
FIGURE TITLE
**Schematic representation of
 successive alterations to Test Pit 5
 capital and corbel (1:25)**

- A. plan (existing)
- B. plan (as built)
- C. Front view, facing south-east (existing)
- D. Side view, facing north-east (existing)
- E. Front view, facing south-east (as built)
- F. Front view, facing south-east (as first modified)

- 3.13 However, it was noted above that the fluting on the cut back pier is itself truncated by the cutting away to insert the blocking wall and this wall (represented archaeologically by the scar in the 1868 south wall) is thought to belong to the 1540 construction. It may be, however that this trimming of the corbel relates to the later insertion of a four-centred arch in the blocking wall. What appears to be such an arch is shown in a view of 1821 and it appears again in the Street photograph. The function of this arch and its jamb was to support the blocking wall in the arcade at first floor level over the passageway. It may have replaced an earlier timber beam. The magnificent and expensive fireplace now in room G5 was originally in this building, and it is evidence of further work in the later 16th century, which may provide a context for further work in the house.

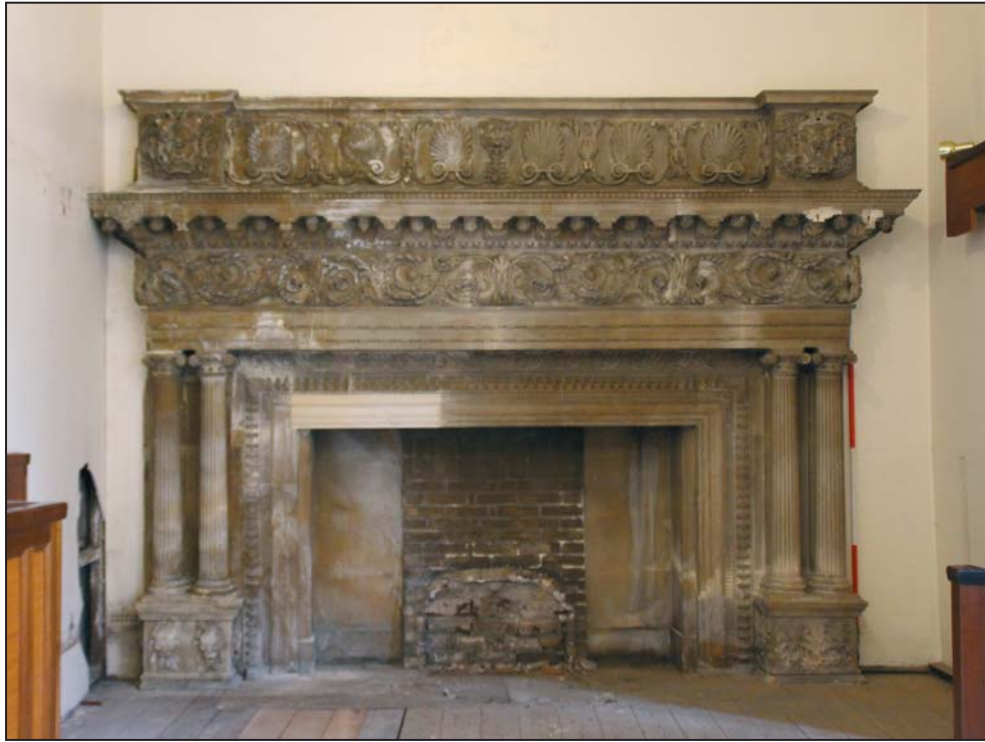
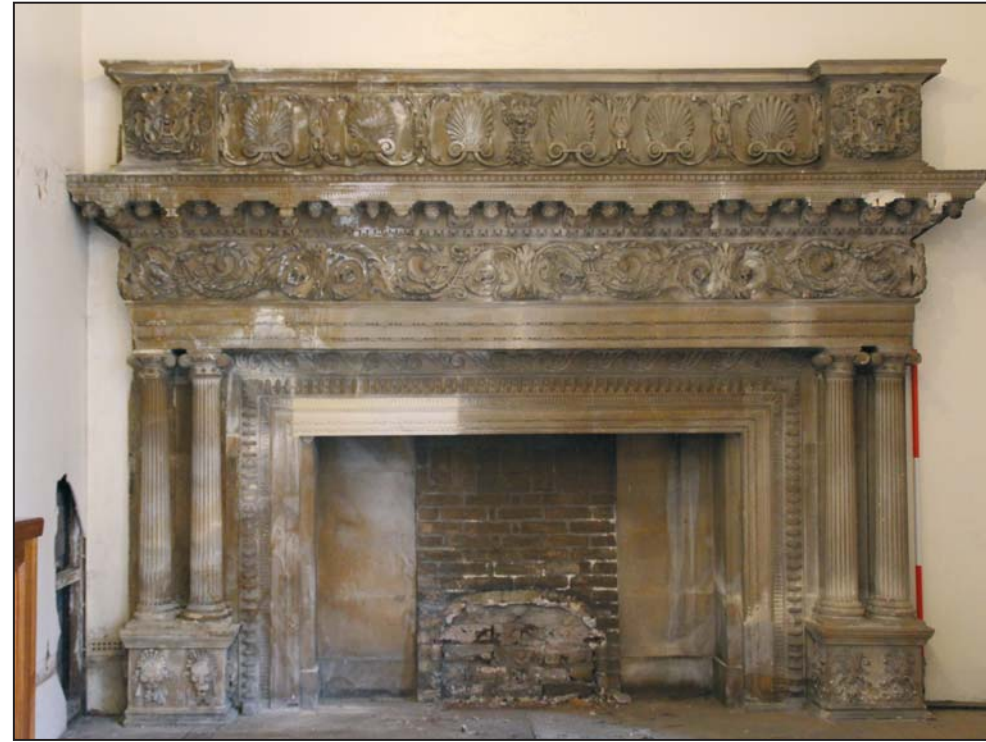
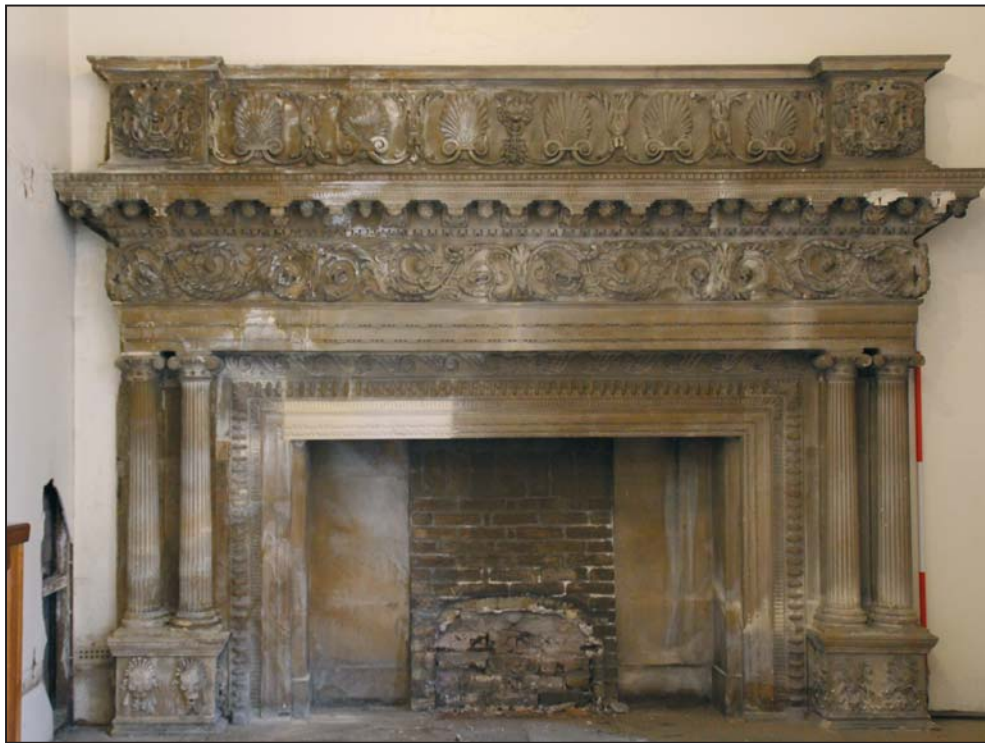
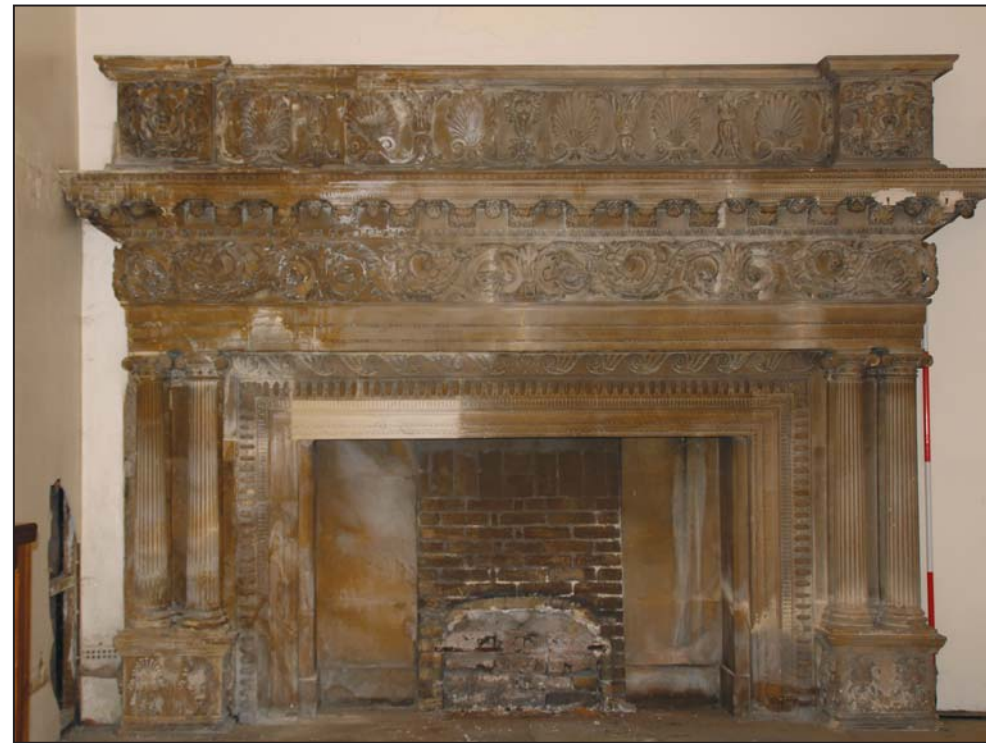
DRAWN BY	JB	PROJECT NO.	4728	FIGURE NO.
CHECKED BY	JB	DATE	30.04.15	19 to 22
APPROVED BY	SC	SCALE	@A3 NA

- 19 Chimneypiece in G5. Scale 2m, no flash. JPEG 1735.
- 20 Chimneypiece in G5. Scale 2m, no flash. JPEG 1736.
- 21 Chimneypiece in G5. Scale 2m. No flash. JPEG 1737.
- 22 Chimneypiece in G5. Scale 2m. Flash. JPEG 1738

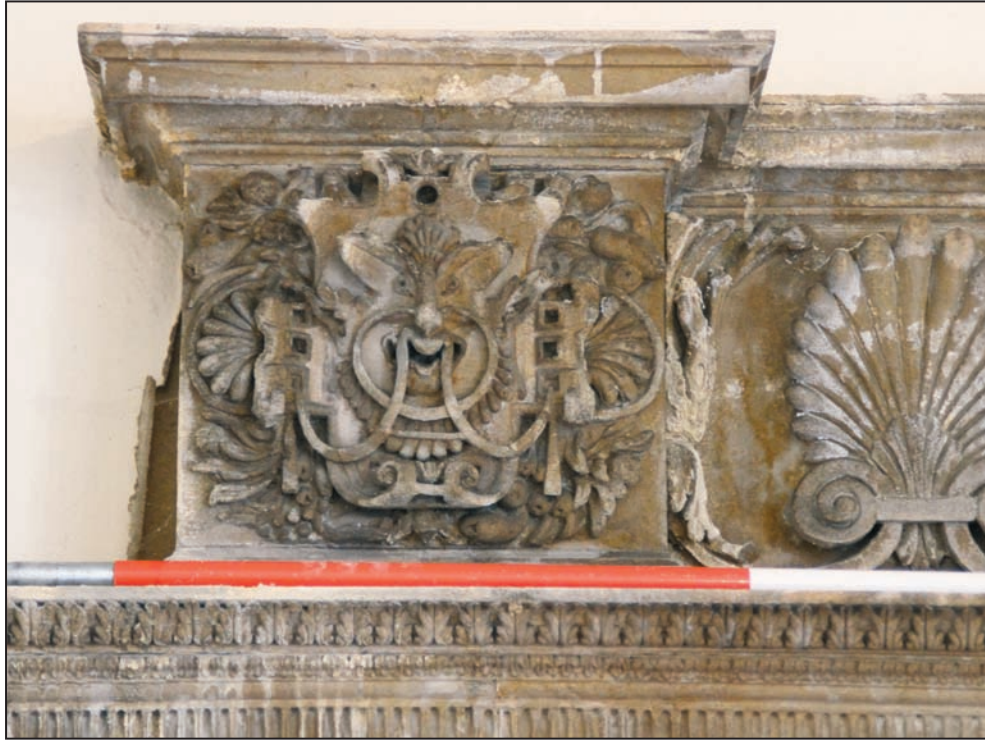
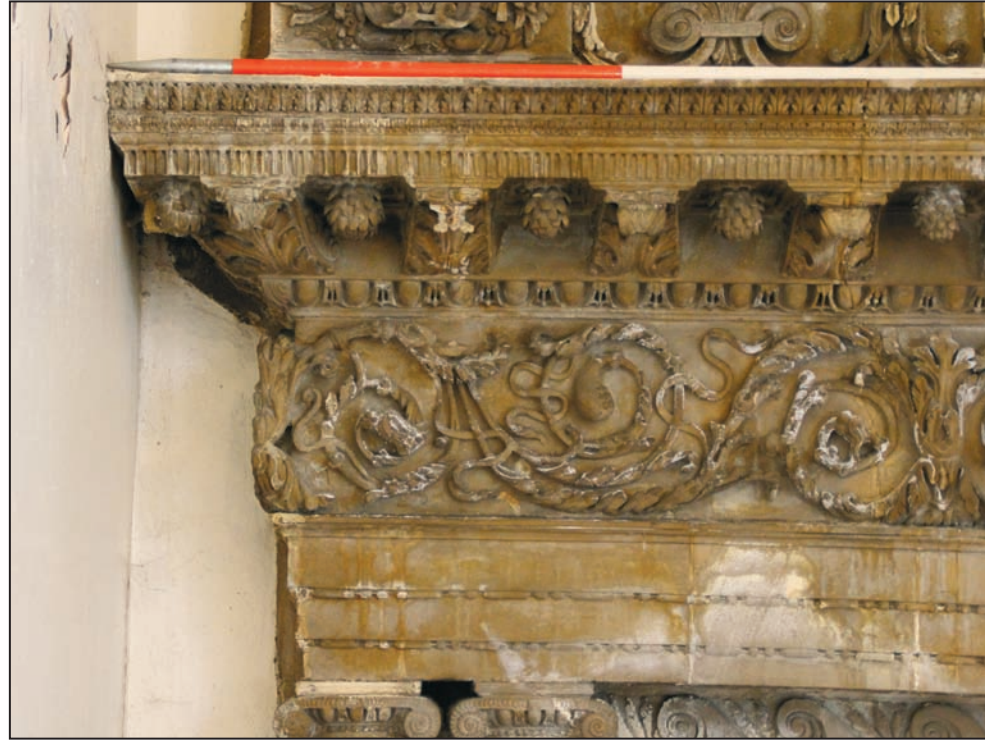
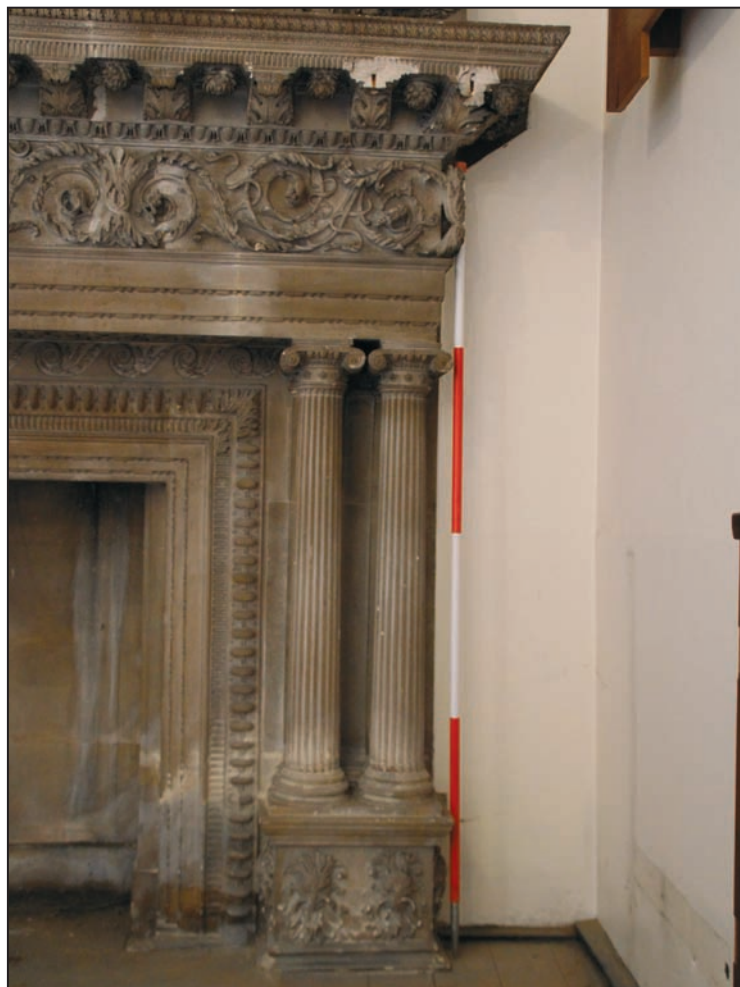
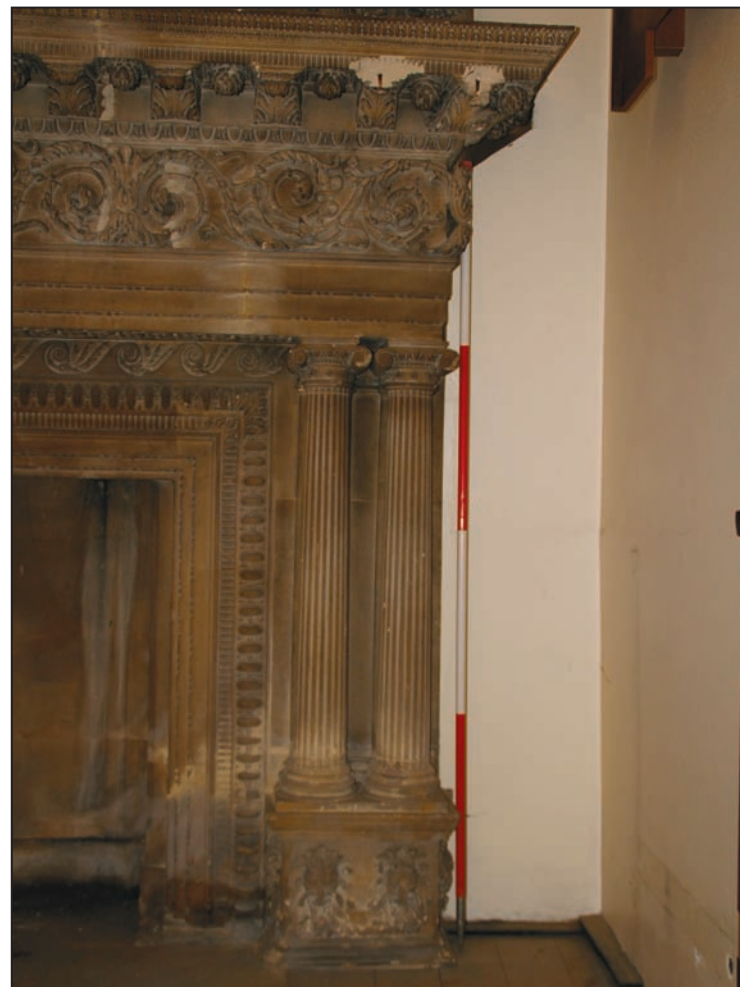
- 23 G5. Detail of left hand attic panel, and cornice below. Scale 0.5m divisions. JPEG 1740.
- 24 G5. Detail of left hand end of cornice. Scale 1m. JPEG 1741.
- 25 G5. Right hand end of fireplace, columns, entablature etc. Scale 2m. JPEG 1743.
- 26 G5. Right hand end of fireplace, columns, entablature etc, flash. Scale 2m. JPEG 1744
